# Manhole Inspection Summary

Manhole # S37Y1\_020MH

Insp Date: **11/15/07 12:54 PM**

**Location** Address: **3714 2nd St**

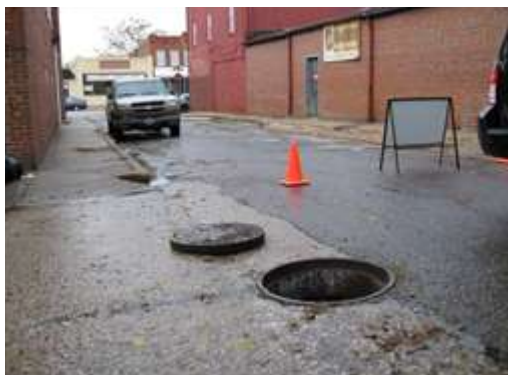
Location View

2nd Hanover

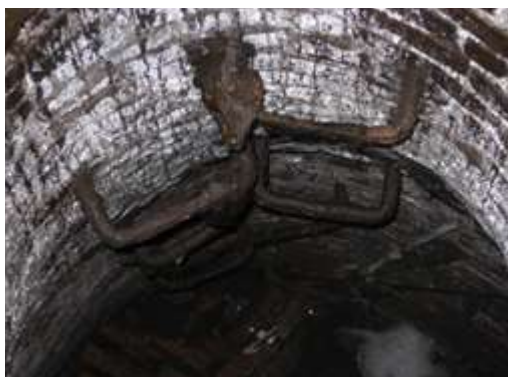
Defect 1

Count: **6** Missing: **0** ☒ **Corroded**

☒ **Evidence Of Surcharge** Depth: **10** (ft.) ☒ **Active Surcharge Present**

Surcharge on steps

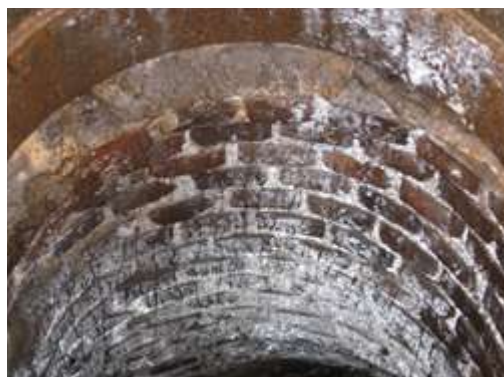
Defect 2

Offset: **2** (in.)

Frame offset/intrusion

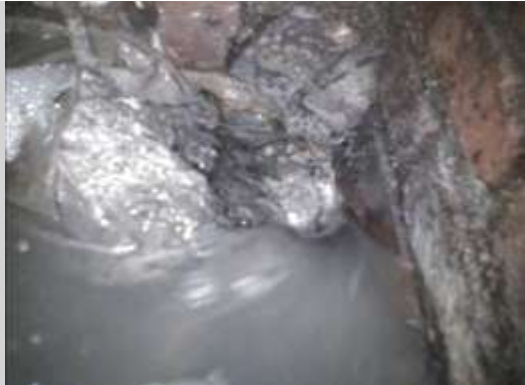
12 O'Clock Outflow

10 in. Circular Gravity Sewer  
Pipe Out @ 12 O'Clock

Pipe Height: **3.6** (in.) Rod and Bar (Angled)  
Pipe Material: **Unknown** ☐ Pipe Lined  
Invert Depth: **1.00** (ft.) Flow Characteristics: **Slow**  
Deposits: ☐ None ☒ Mud ☒ Sludge ☒ Debris ☒ Grease  
Silt Depth: **5** (in.) Deposits Extent: **Heavy**  
Infiltration: **None** Pipe Seal Cond: **Unknown**

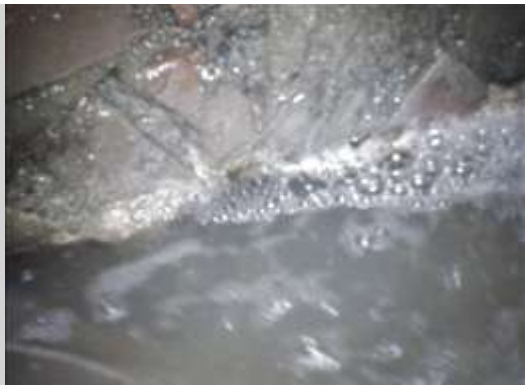
3 O'Clock Inflow

8 in. Circular Gravity Sewer  
Pipe In @ 3 O'Clock

Pipe Height: **3.6** (in.) Rod and Bar (Angled)  
Pipe Material: **Clay** ☐ Pipe Lined  
Invert Depth: (ft.) Flow Characteristics: **None**  
Deposits: ☒ None ☐ Mud ☐ Sludge ☐ Debris ☐ Grease  
Silt Depth: (in.) Deposits Extent:  
Infiltration: **None** Pipe Seal Cond: **Unknown**

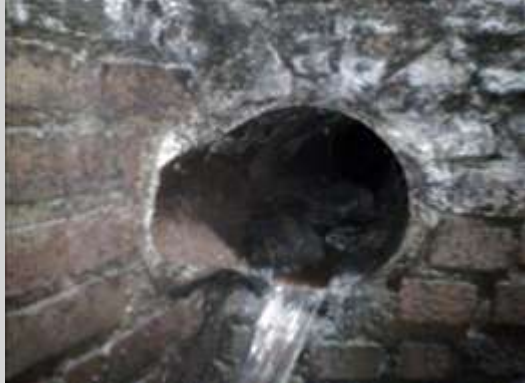
6 O'Clock Inflow

10 in. Circular Gravity Sewer

Pipe In @ 6 O'Clock

Pipe Height: **7.2** (in.) Rod and Bar (Angled)

Invert Depth: **9.94** (ft.) Flow Characteristics: **Fast**

Infiltration: **None** Pipe Seal Cond: **Sound**

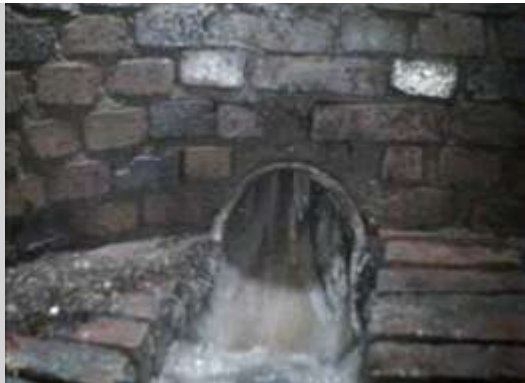
9 O'Clock Inflow

8 in. Circular Gravity Sewer

Pipe In @ 9 O'Clock

Pipe Height: **8.4** (in.) Rod and Bar (Angled)

Invert Depth: **10.90** (ft.) Flow Characteristics: **Fast**

Infiltration: **None** Pipe Seal Cond: **Sound**
